Re: Scurry County Courthouse - Structural Assessment
Snyder, Texas
JQ Project No. 3230107

Scurry County Courthouse - Structural Assessment, Snyder, Texas

JQ Project No. 3230107

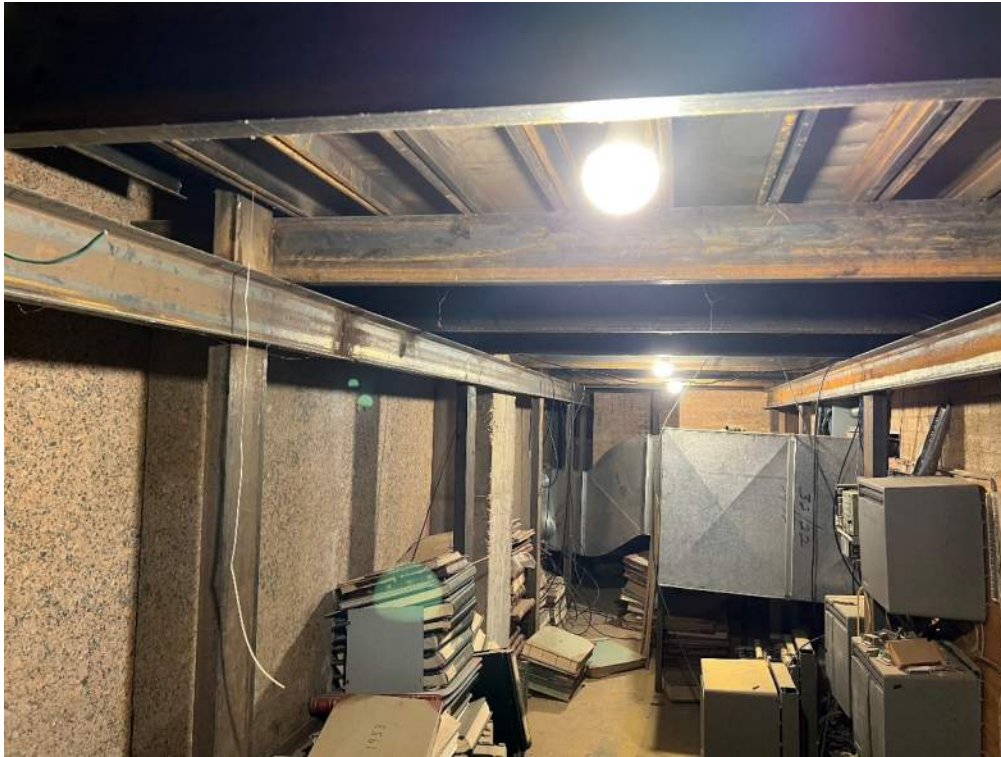
- The steel framing in the expanded floors is in good condition with no observed signs of distress or deterioration. Refer photograph 1.

Photograph 1 – Typical construction within storage areas within expanded floors.

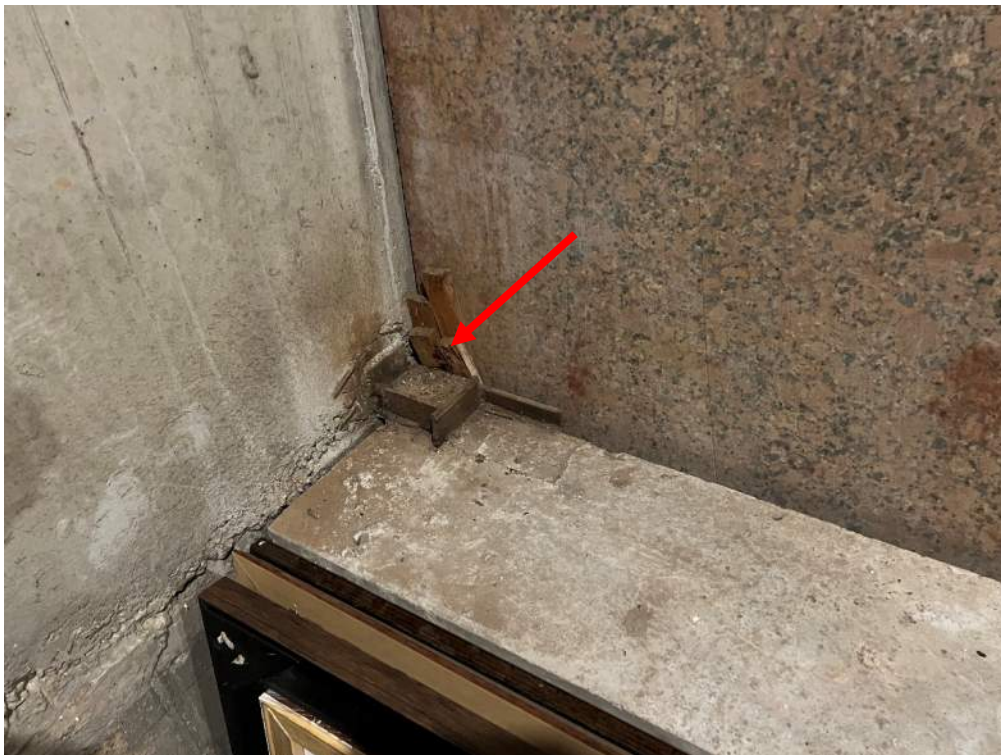
- The precast concrete beams and cast-in-place concrete columns supporting the granite façade are in good condition with no observed signs of distress or deterioration. Refer photograph 2.

- The observed supports for the granite façade are in general conformance with the support configurations detailed in the original installation drawings. Some surface corrosion is present, but no significant material loss has occurred. Refer photographs 2, 3 and 4.

Photograph 2 – Typical gravity connection at precast concrete beam and cast-in-place concrete column supporting granite façade.

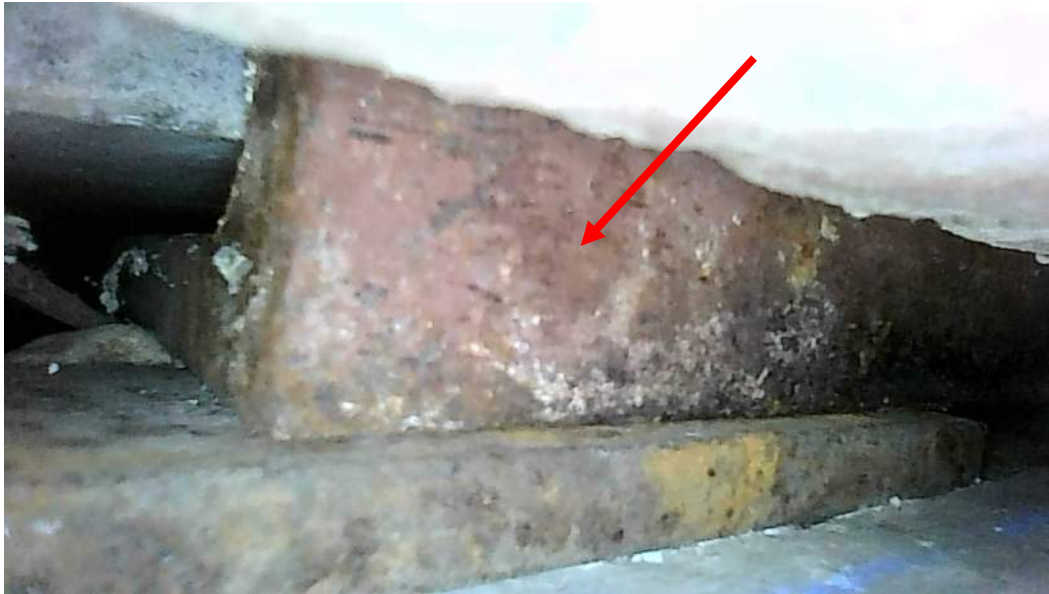
Photograph 3 – Typical support angle at horizontal joints in granite panels.

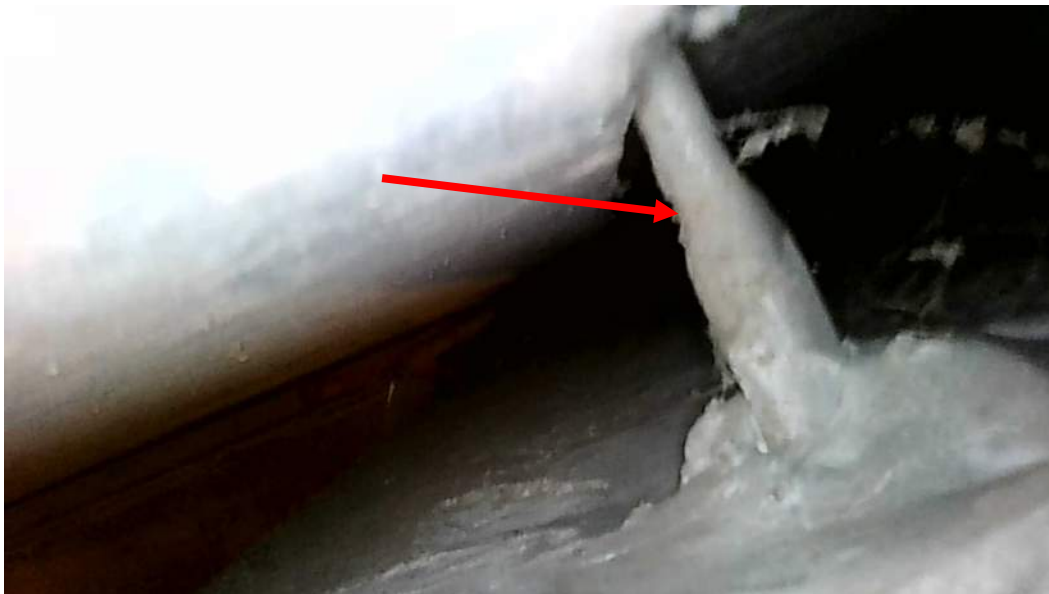
Photograph 4 – Typical lateral restraint anchor at horizontal joints in granite panels.

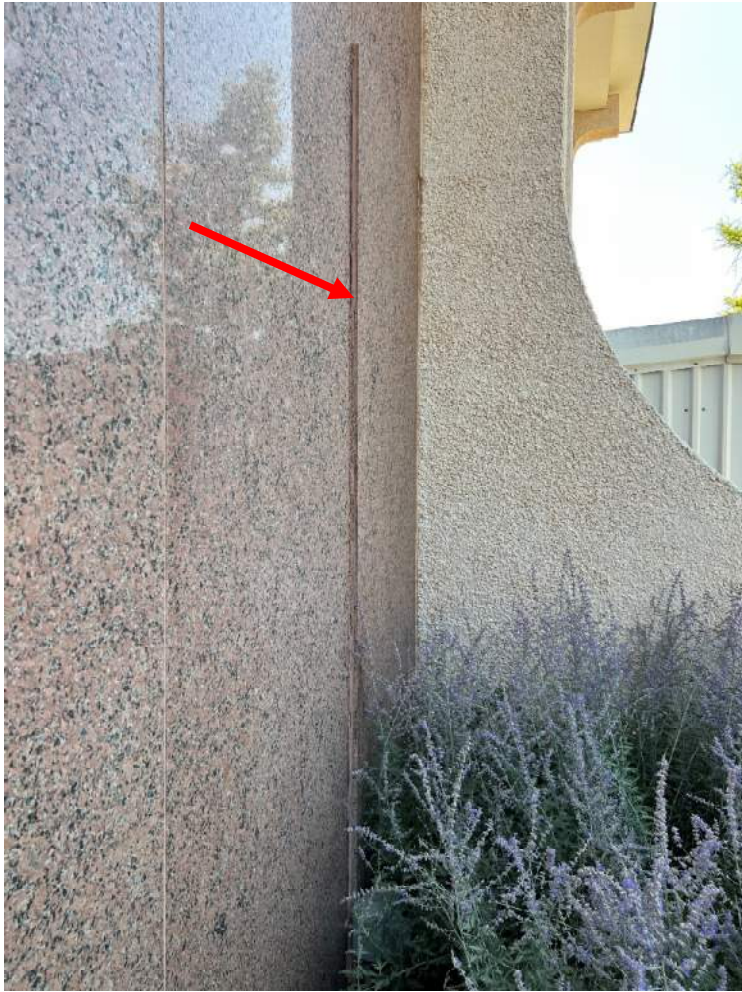
- One (1) panel on the south elevation has shifted outward approximately 1 inch at the top of the panel and 1 1/4 inch at the bottom of the panel. At this location, the lateral ties for the panel appear to have detached from the supporting precast concrete beam. Refer photographs 5 and 6.

Based on observations at the three (3) granite panels which have experienced lateral displacements and absent cracking or spalling of the stone, the pins at the base of the displaced panels appear to be missing and the lateral restraint at the top of the panels appear to have become dislodged from the supporting precast concrete beams. Absent installation of new lateral restraints, the displacement of these panels may continue to increase. Therefore, supplemental lateral connections should be installed at these locations.

Photograph 5 – Approximate 1 1/4 inch lateral displacement at granite panel on south elevation.

- The one (1) granite panel on the south building elevation which has laterally displaced over 1 inch should be reset into proper alignment with the adjacent panels. The top and bottom of this panel should then be reattached to the supporting structure with steel angles attached with anchors drilled and set with epoxy into the back of the panels and into the supporting structure to provide lateral restraint. Damaged joint sealants around the perimeter of the panel should be replaced.

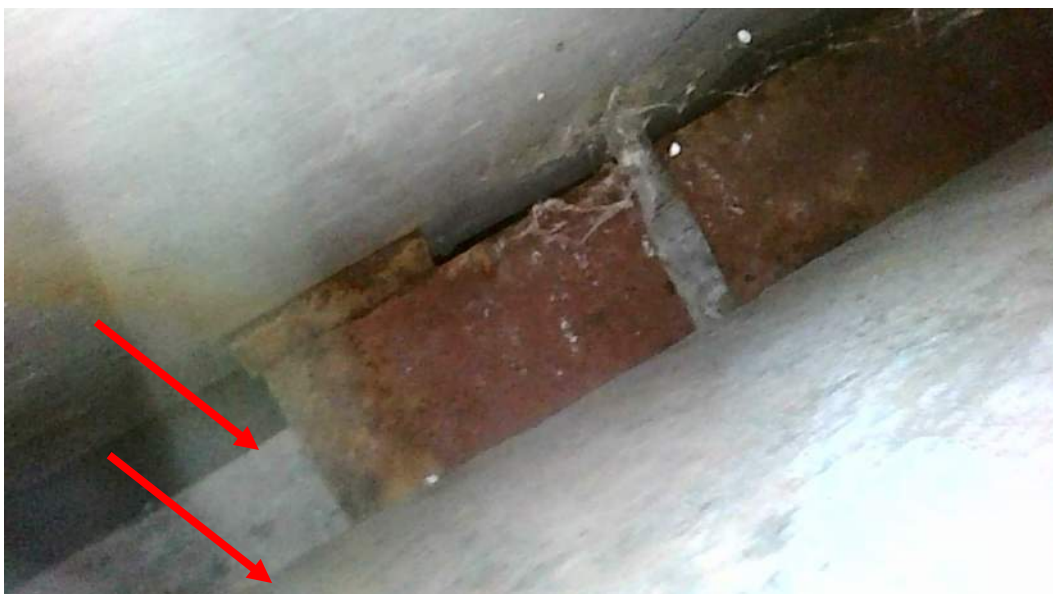
Photograph 6 – Connection at top of displaced granite panel on south elevation with offset in stone.

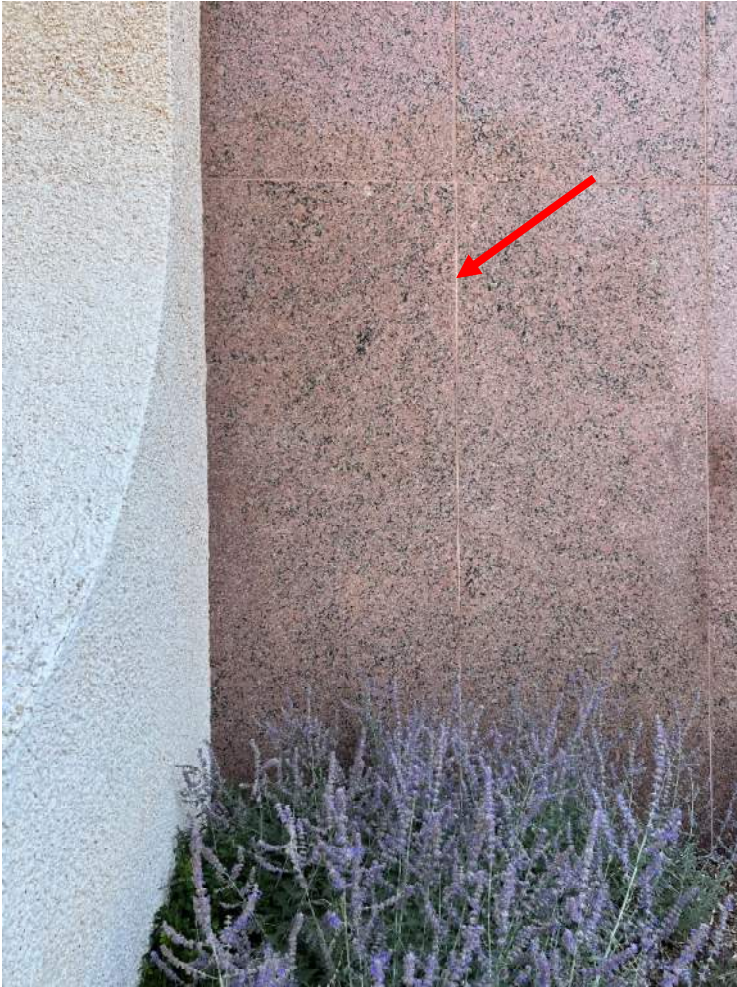
- One (1) panel on the south elevation has shifted outward approximately 1/4 inch. Refer photograph 7.
 - One (1) panel on the north elevation has shifted outward approximately 1/8 inch. Refer photograph 8.

Photograph 7 – Approximate 1/4 inch lateral displacement at granite panel on south elevation.

- The two (2) granite panels which have laterally displaced 1/4 inch or less do not require relocation. However, the top and bottom of each panel should be reattached to the supporting structure with steel angles attached with anchors drilled and set with epoxy into the back of the panels and into the supporting structure to provide lateral restraint. Damaged joint sealants around the perimeter of the panel should be replaced.

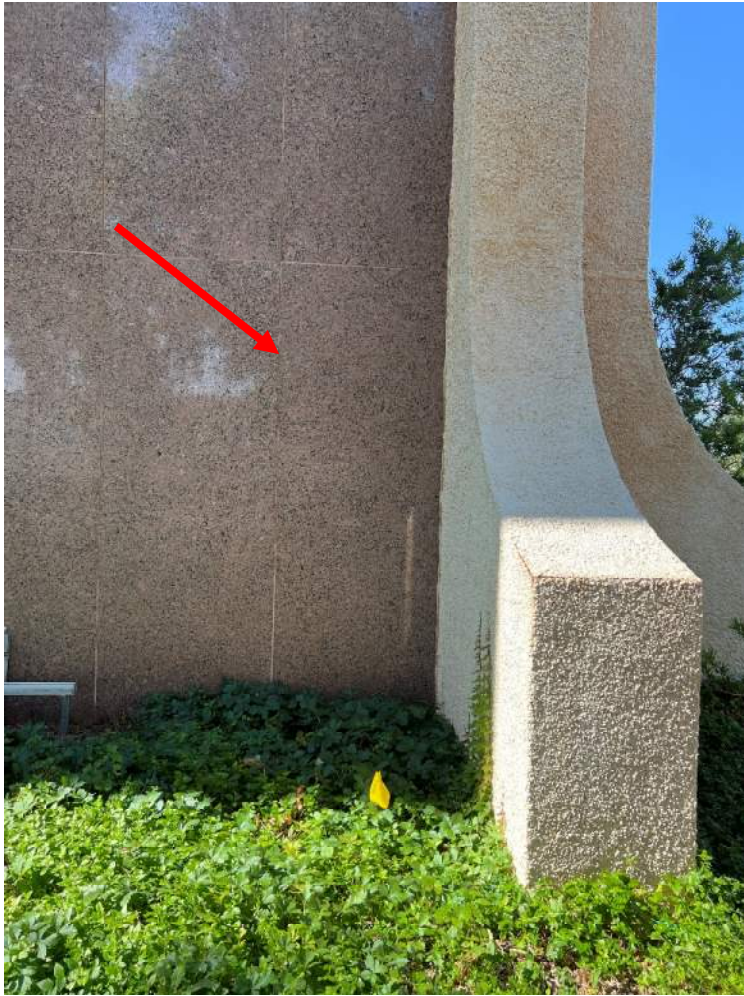
Photograph 8 - Approximate 1/8 inch lateral displacement at granite panel on south elevation.

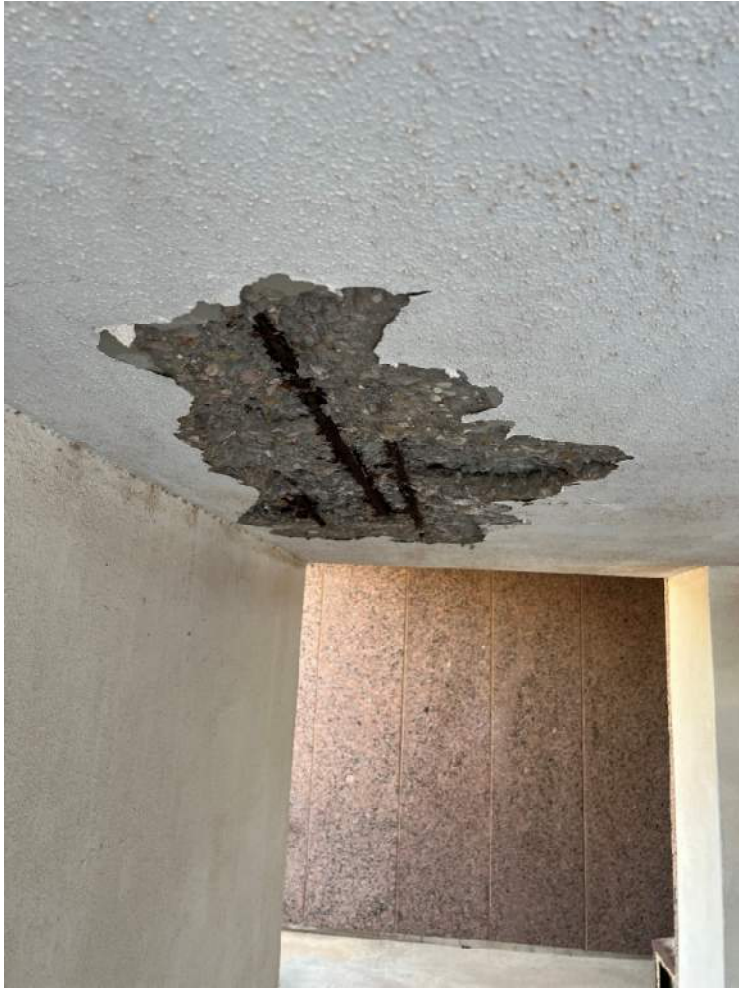
- Spalling of the underside of the concrete slab at the west building entry has occurred due to corrosion of the embedded reinforcing steel caused by long term exposure to moisture. Refer photograph 9.

Photograph 9 – Damaged and delaminated concrete on underside of slab at west entry.

- The damaged and delaminated concrete at the underside of the west entry slab should be removed until sound concrete is exposed. After removal of all corrosion from the exposed reinforcing steel, the concrete should be patched with a non-sag cementitious repair mortar such as SikaTop 123 Plus or equal installed in accordance with manufacturer's recommendations.

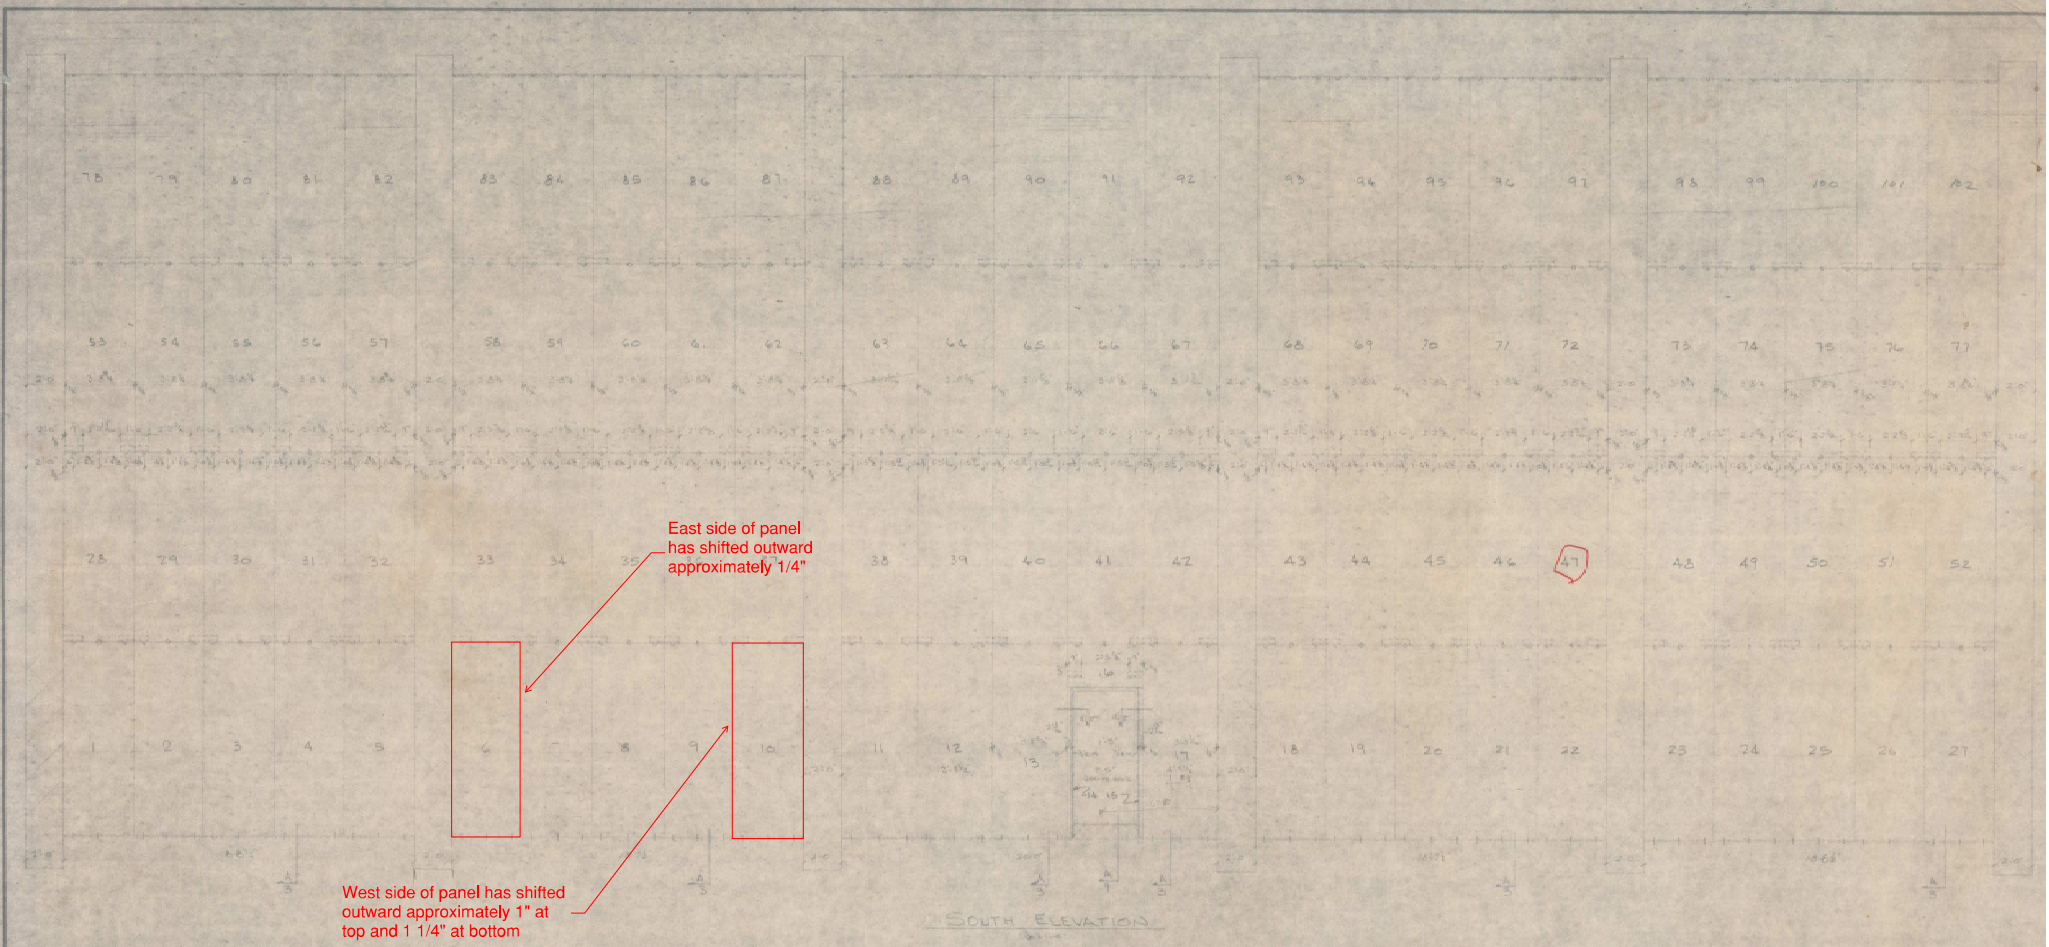
South Elevation

- No spalls or cracking was observed on the interior or exterior faces of the granite panels.
- Granite panels have shifted outward at three locations at the bottom of the exterior walls. Refer to attached building elevations for locations.

East side of panel
has shifted outward
approximately 1/4"

West side of panel has shifted
outward approximately 1" at
top and 1 1/4" at bottom

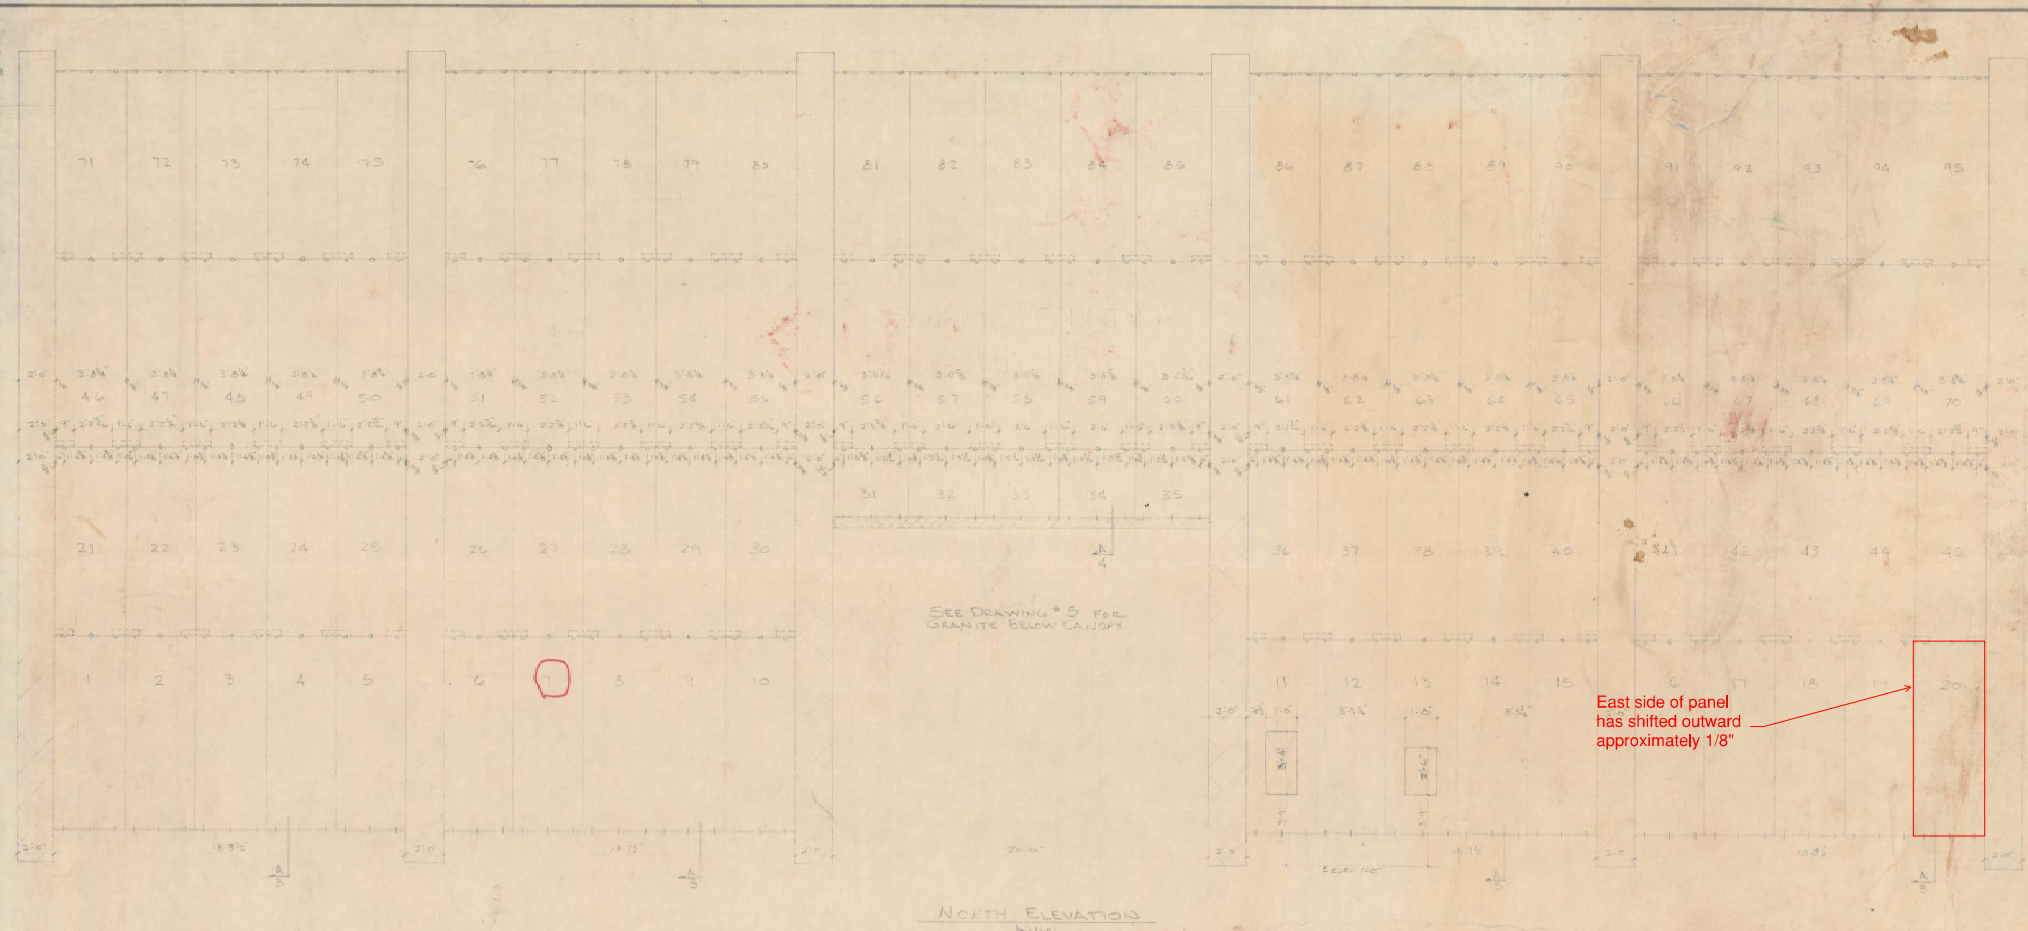
North Elevation

East side of panel has shifted outward approximately 1/8"

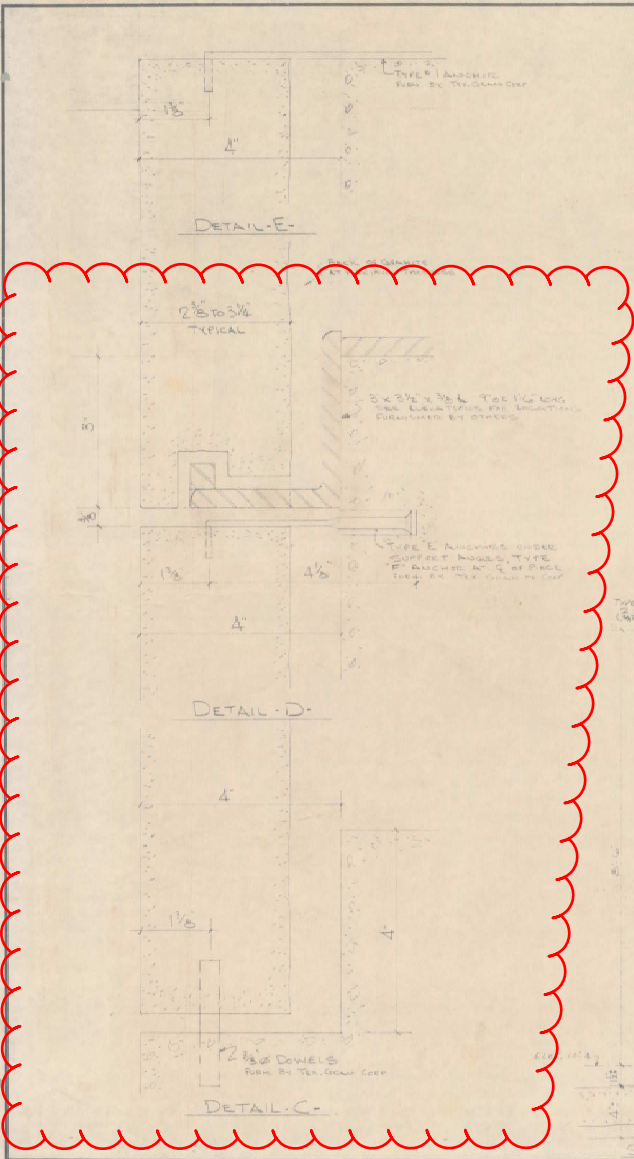
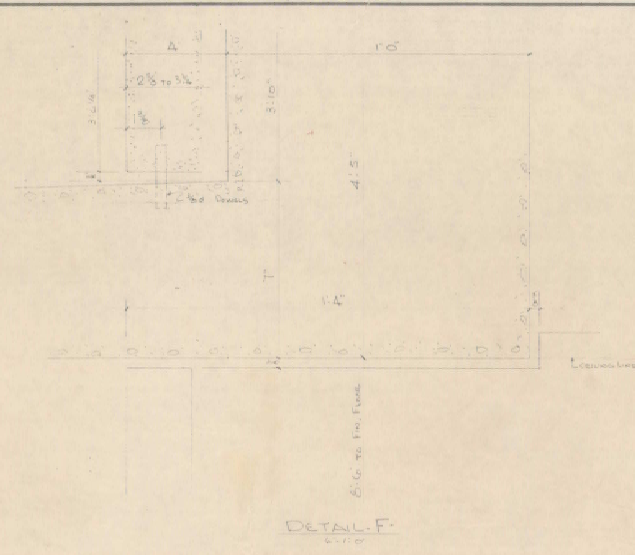
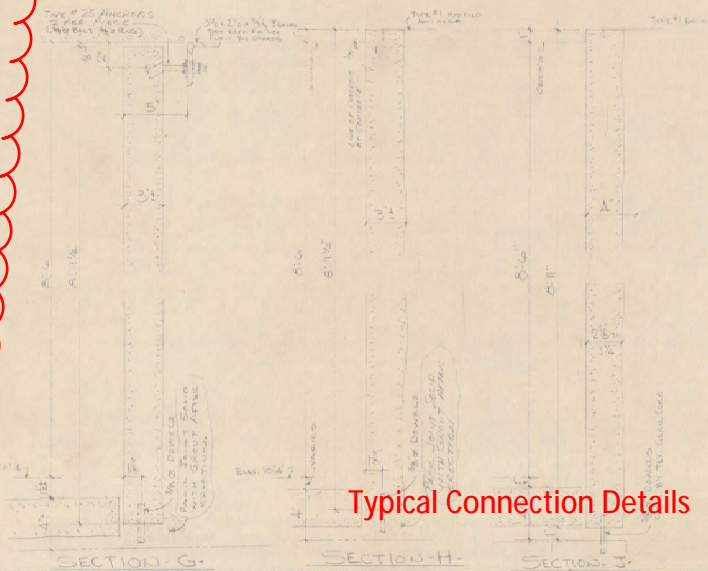
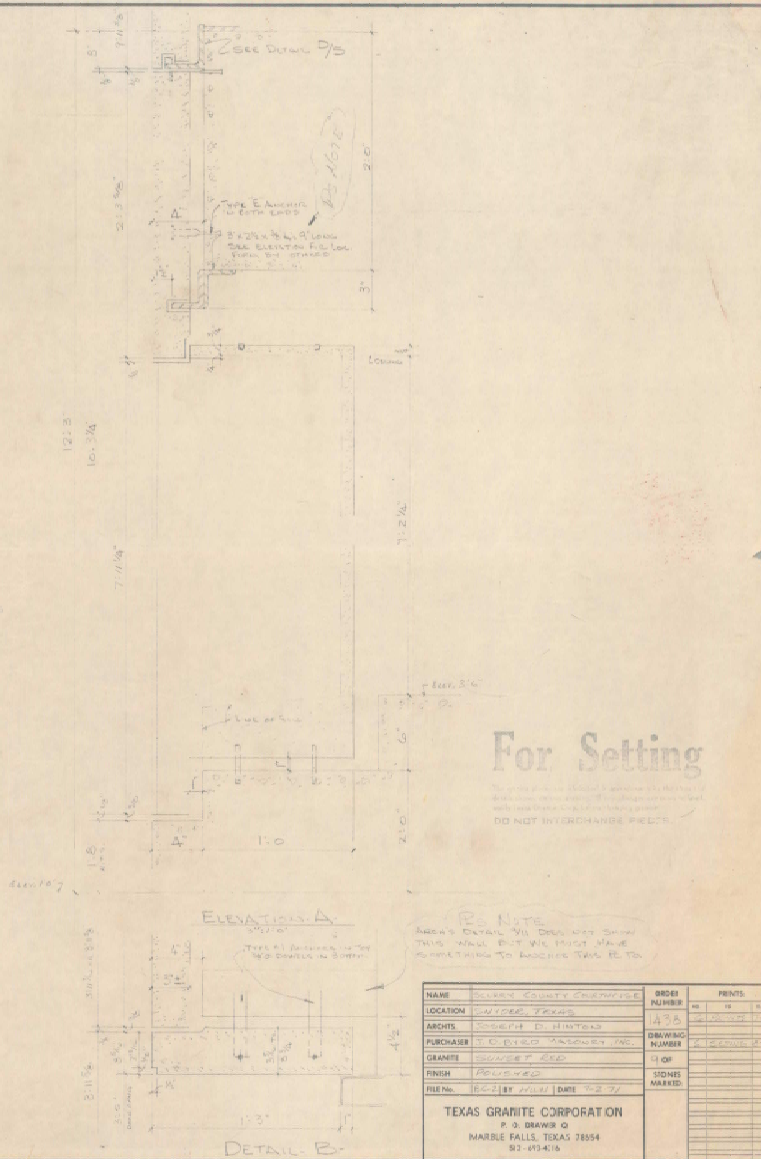
Typical Connection Details

Per the original granite installation drawings, the base of the granite panels at the bottom of the exterior walls are laterally restrained by a vertical steel dowel drilled and set into the concrete foundation and projecting upward into a drilled hole in the base of the stone. At elevated joints, the top of the granite panels are laterally restrained by a bent steel tie which is drilled and set into the supporting precast concrete beams and the bottom of the panels are vertically and laterally supported by a steel angle set into a kerf cut into the base of the stone and welded to embedded steel plates in the supporting precast concrete beams. These types of connections were typically used at the time of granite panel installation. The connections are depicted in the attached original typical connect details drawing.
